8
9 **SUPERIOR COURT FOR THE STATE OF CALIFORNIA**
10 **FOR THE COUNTY OF ALAMEDA**

Case No. RG-11-600721

**DECLARATION OF STEVEN E.
RUBIN IN SUPPORT OF
DEFENDANTS' OPPOSITION TO
MOTION TO ENFORCE AND MODIFY
CONSENT JUDGMENT**

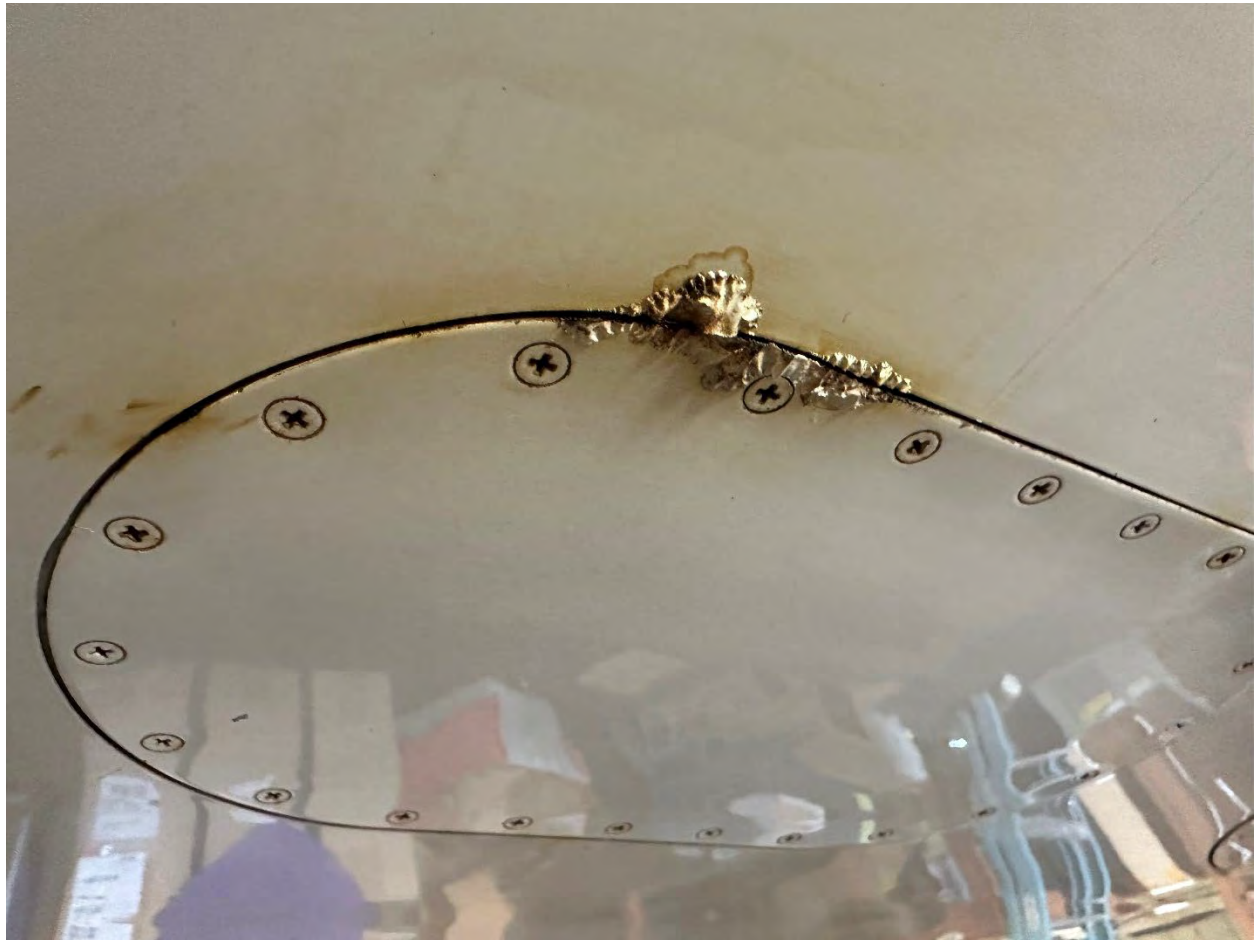
EXHIBIT B

4. On December 12, 2024, I visually observed what appeared to be fuel seeping around N6867L’s wing access panels. The same areas appeared to have paint that was bubbled around the access panels. I noticed the same thing happening around the access panel on the top of the wing.

5. Photographs of N6867L’s affected areas were taken for me by Michael Luvara, an aeronautical engineer and pilot with whom I know to have experience with the potential problems associated with G100UL. Attached hereto as **Exhibits B and C** are photographs, which I have reviewed and affirm are true and correct, of N6867L’s wing access panels, showing the seeping and bubbled paint. On December 15, 2024, I took another picture of the affected area on

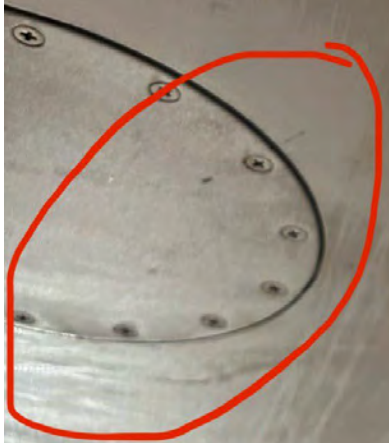
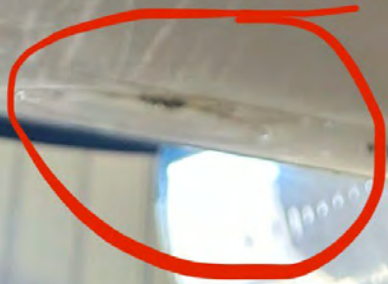
Left wing
DEC 15

1 N6867L’s left wing, which I annotated with “left wing dec 15” and circled the access panels; this
2 image in attached hereto as **Exhibit D**, which I have reviewed and affirm is true and correct. On
3 December 30, 2024, Mr. Luvara took additional pictures of the affected areas, which appeared to
4 show the condition having worsened. I also annotated this photograph with “left wing dec 30”
5 and again circled the affected areas; this image, which I have reviewed and affirm is true and
6 correct, is attached hereto as **Exhibit E**.

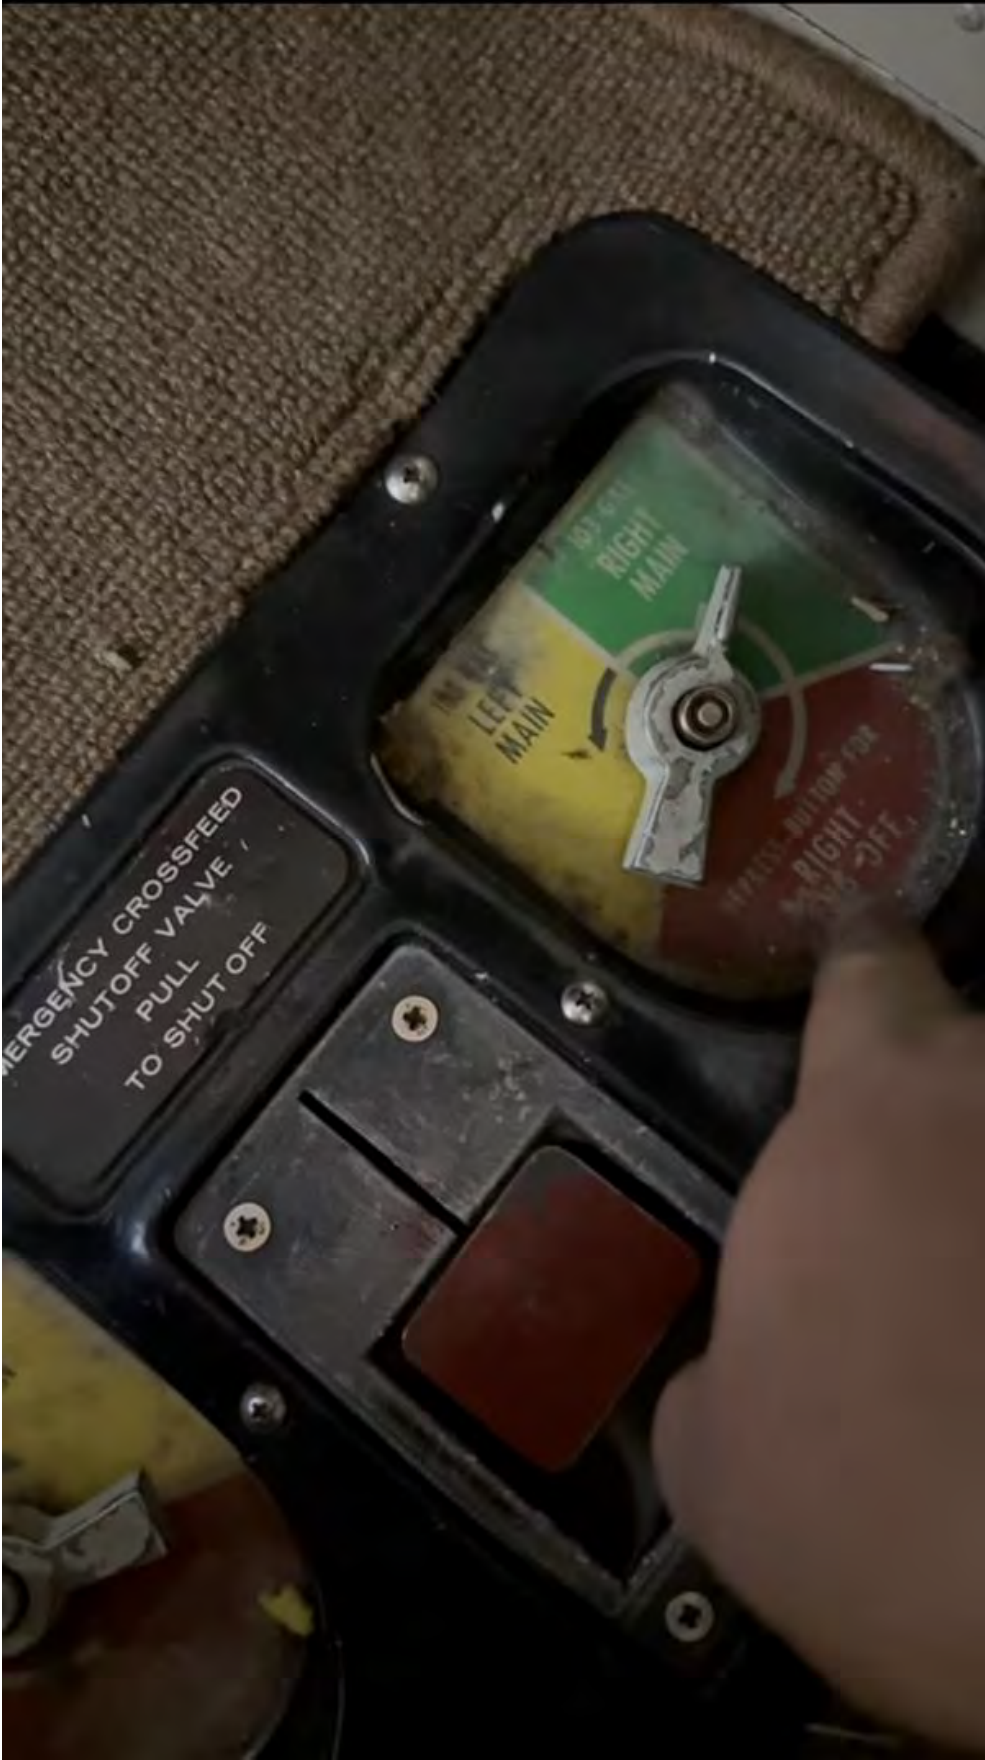
EXHIBIT H

3 14. On February 16, 2025, I took a video of this on my personal cellular telephone and
4 sent it to Carsten Hoyt, General Counsel, General Aviation Manufacturers Association, for
5 review. On February 17, 2025, Mr. Hoyt took two screenshots from my video, which I have
6 reviewed and affirm are true and correct and are attached hereto as **Exhibit H** (this screenshot
7 depicts the right fuel crossfeed actuator with my finger pointing to it) and **Exhibit I** (this
8 screenshot depicts the shutoff tab, with my finger pointing to it), for reference. When I attempted
9 to operate the right fuel crossfeed actuator, for the right engine, it would not properly switch from
10 the green-colored “right tank” selector position to the yellow-colored “left tank” position; it
11 seemed the right actuator would not switch from the right tank to the left tank. Additionally,
12 when I attempted to operate the shutoff tab, it required me to exert significant physical force to

13 pull it up, which indicated to me that something was causing it to stick. It is noteworthy to
14 mention that I was standing on the ground when I attempted to pull the shutoff tab, and that I do
15 not think, based on the amount of physical force I had to exert, that I could operate the shutoff tab
16 while seated in the airplane—especially while flying it. On February 16, 2025, I also spoke with
17 my mechanic, who stated seals or gaskets in the fuel line, around the actuators, could be swollen
18 or damaged, which has caused this problem.
