9 **SUPERIOR COURT FOR THE STATE OF CALIFORNIA**  
10 **FOR THE COUNTY OF ALAMEDA**  
11

Case No. RG-11-600721

**DECLARATION OF SEAN PATRICK  
KELLEY IN SUPPORT OF  
DEFENDANTS' OPPOSITION TO  
MOTION TO ENFORCE AND MODIFY  
CONSENT JUDGMENT**

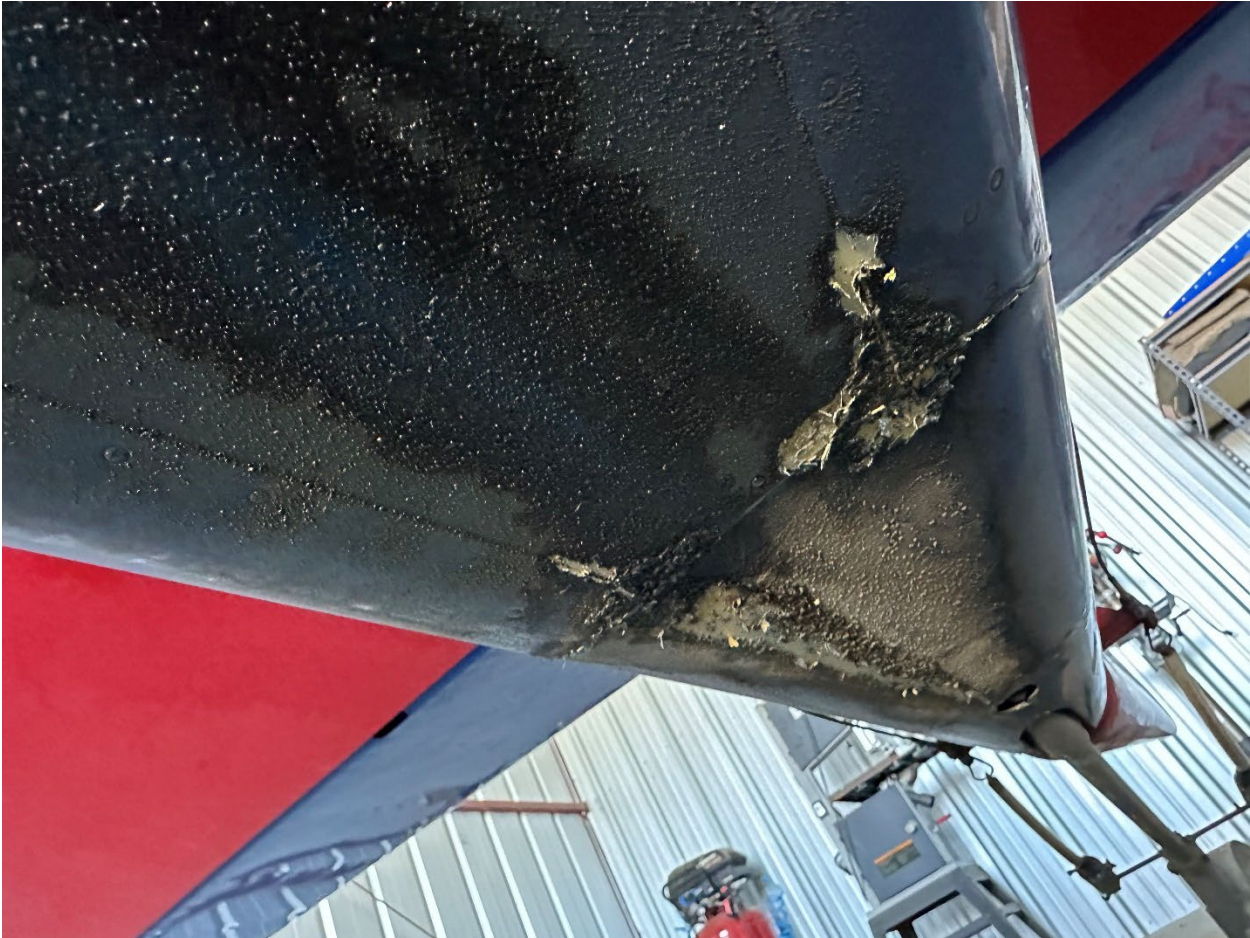
# **Exhibit B**

8 5. On January 12, 2025, I observed fuel in the floor area of N146WB's cockpit (the  
9 fuel likely traveled along the bottom of the forward wing spar into the cockpit), on the underside  
10 of the wing, down to the flap, and down the airplane's belly. I also observed bubbled and peeled  
11 paint on the cockpit floor, the underside of the wing, the flap, and at several locations on the belly  
12 extending to the underside of the tail. Pieces of paint had already fallen to the floor along the  
13 length of the aircraft when the leak was discovered. As a result, I collected a 3-gallon fuel sample  
14 of G100UL from the right tank and filled the right tank with 100LL to dilute the G100UL that  
15 remained. I also visually inspected the fuel tanks. N146WB's fuel tanks are part of the inboard  
16 forward wing and fasten to the forward wing spar and the forward fuselage with a design similar  
17 to that of a "wet wing" aircraft. The seams of the metallic components are sealed with a

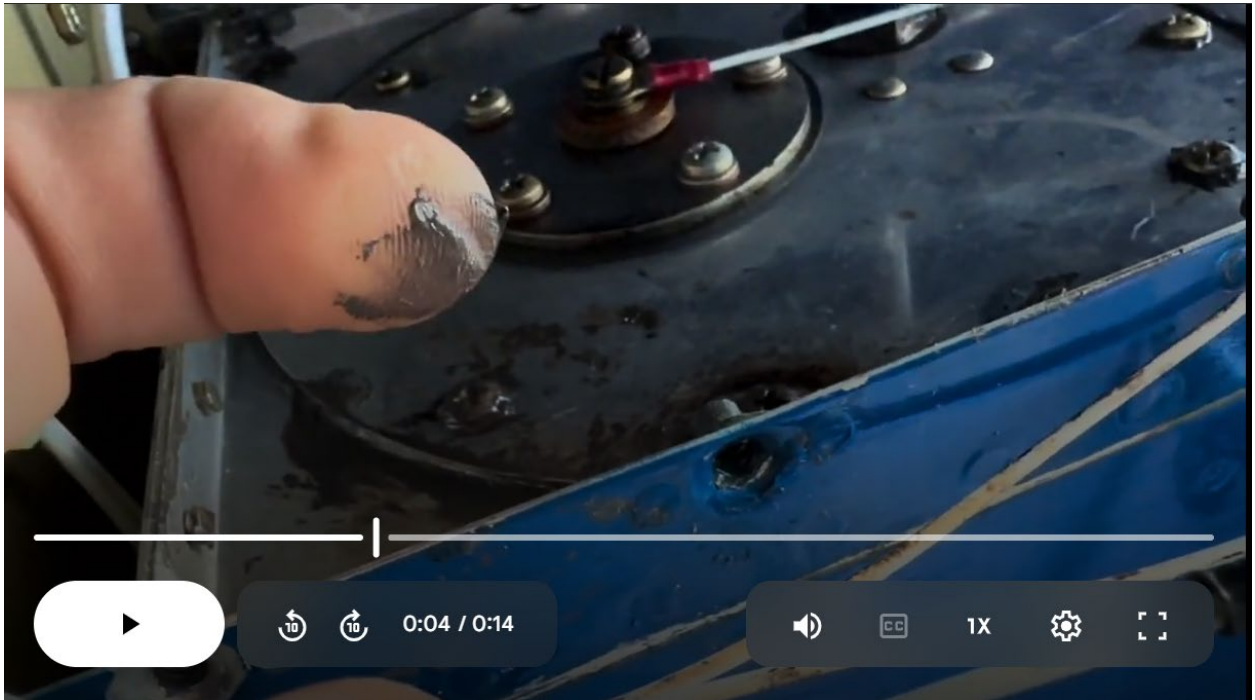
# **Exhibit G**

6 7. An inspection of N146WB's wing fuel tanks was also conducted by Mr. Luvara  
7 and myself; the tanks were documented with a video-producing borescope and photographs.  
8 N146WB's left wing root fuel sender was examined. First, Mr. Luvara touched a substance  
9 believed to be either ProSeal or silicon, which he was able to rub off with his finger and could be  
10 smeared. A captured borescope video shows this, of which a screenshot photograph is attached  
11 hereto as **Exhibit G**. Photographs of N146WB's left wing root fuel sender ProSeal condition are  
12 attached hereto as **Exhibits H and I**. I was present when Mr. Luvara took the aforementioned  
13 photographs and videos. I have further reviewed the aforementioned photographs, including the  
14 video screenshots, and can confirm them to be true and correct.

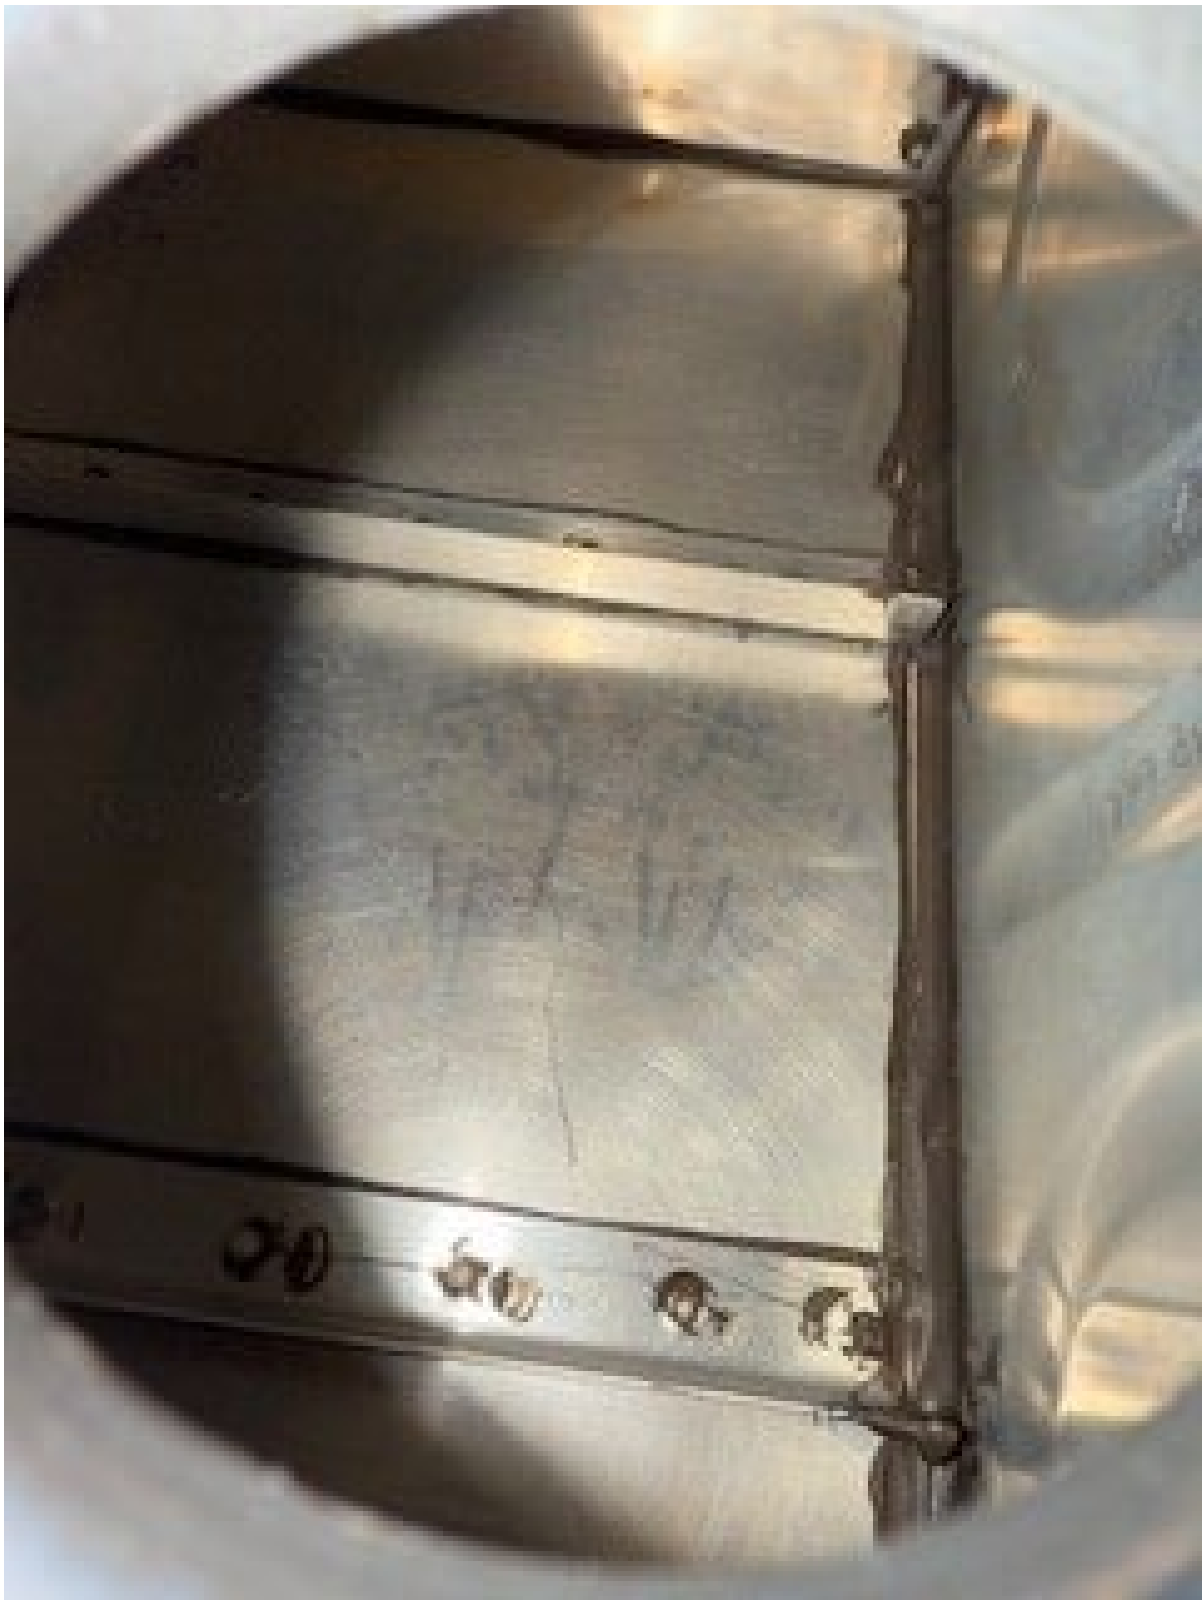
# **Exhibit J**

15 8. On January 29, 2025, Mr. Luvara and I also tested the ProSeal's strength on the  
16 inside of N146WB's fuel tank seams. When Mr. Luvara pressed a screwdriver on the tank's  
17 ProSeal, it appeared the sealant was much softer and pliable than it should be and allowed the  
18 screwdriver to make noticeable indentations. Mr. Luvara and I observed that the ProSeal, in  
19 N146WB's wing fuel tanks, was also so pliable that it could be peeled with ease using a  
20 screwdriver. For reference, when ProSeal is applied to a surface, it quickly hardens and remains  
21 hard and air/water tight.
